Name Of Dam: WESTVACO NO.2 FLYASH LAGOON

Location: ALLEGHENY COUNTY

Inventory Number: VA. 00504

PHASE I INSPECTION REPORT
NATIONAL DAM SAFETY PROGRAM

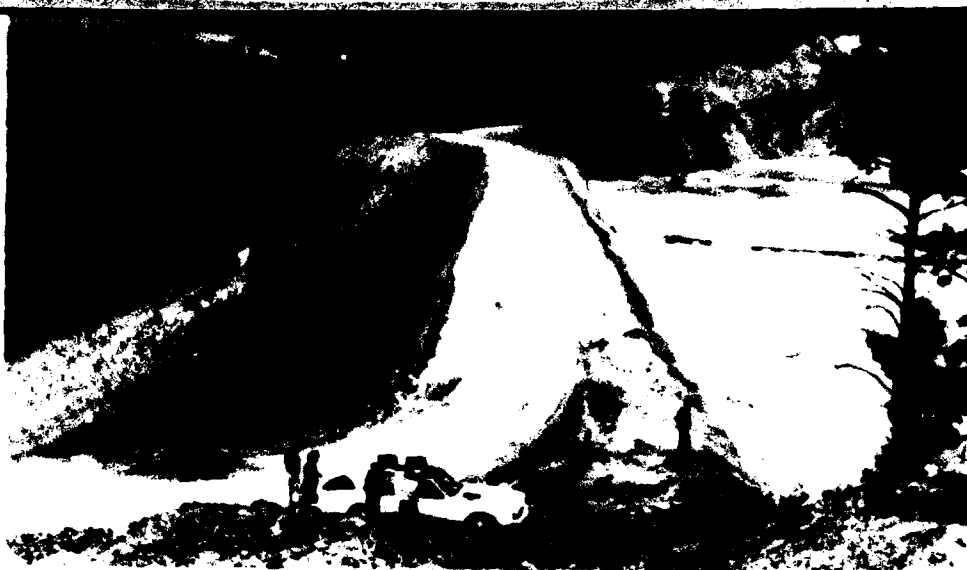
CREST
